USAAEFA PROJECT NO. 79-19

**ARTIFICIAL AND NATURAL ICING TESTS  
PRODUCTION UH-60A HELICOPTER**

**FINAL REPORT**

**JUNE 1980**

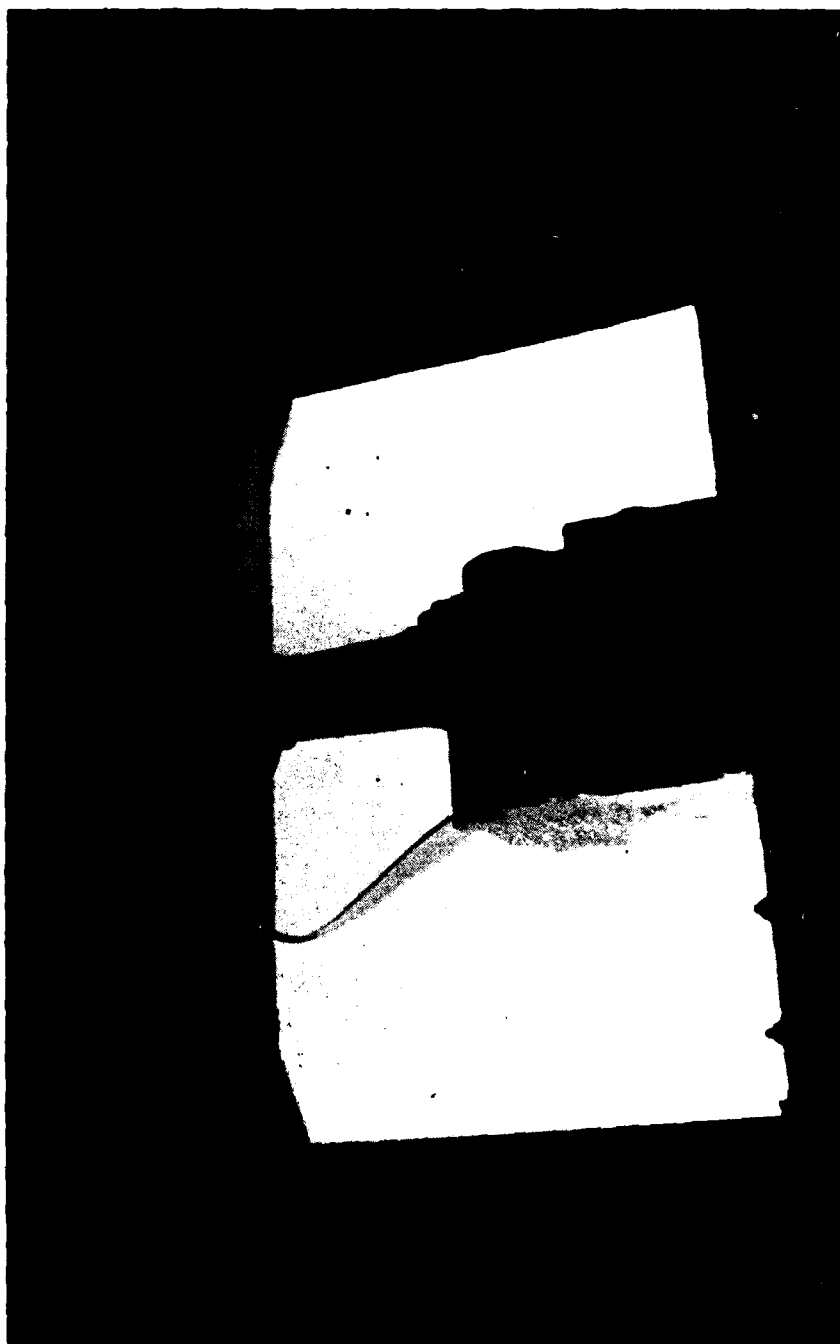
Photo 18. Cargo Hook, with Ice
